Your Inspection Report

XXX Garden Dr
St Louis, MO 63021

Friday, May 20, 2016

RE: Report No. 1142, v.2
XXX Garden Dr.
St Louis, MO
63021

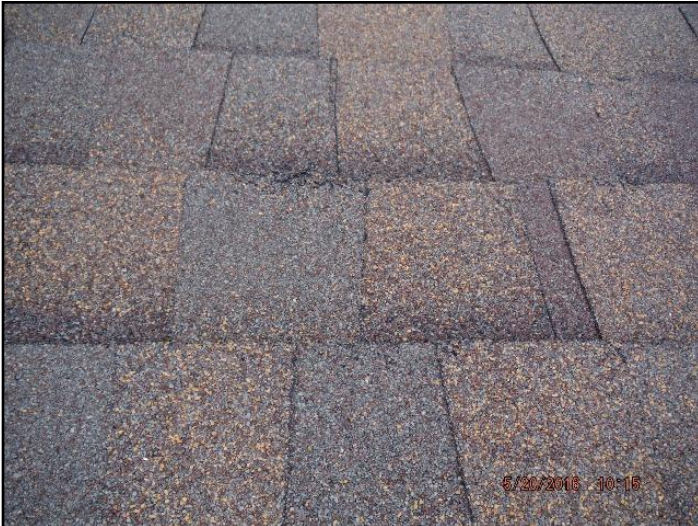
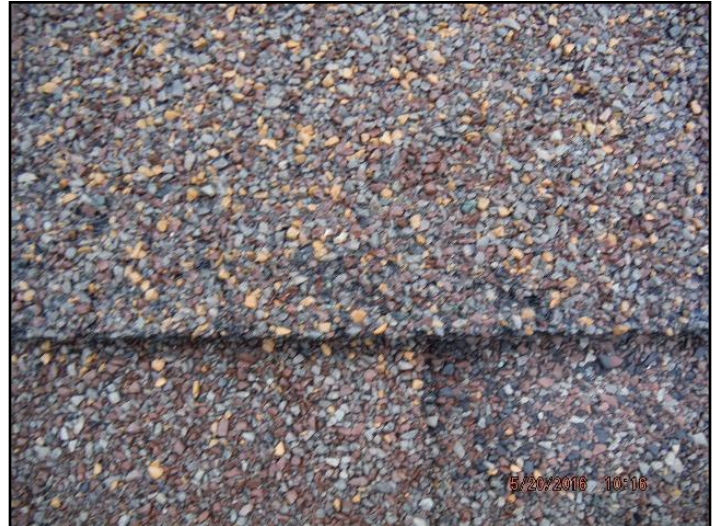
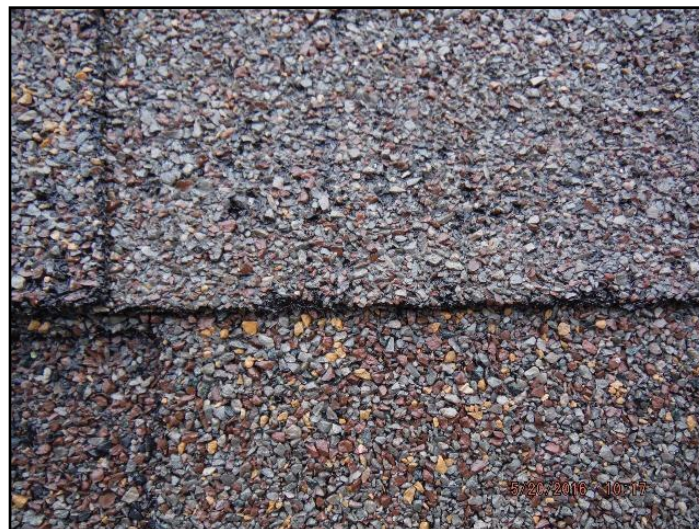
Condition: • Hail damage

Noted what appears to be minor/moderate amounts of hail damage. Roof covering is hard to view/inspect when wet. Recommend further evaluation by a qualified roofing contractor to determine extent of hail damage and repair if needed.

1. Hail damage

2. Hail damage

3. Hail damage

Task: Further evaluation

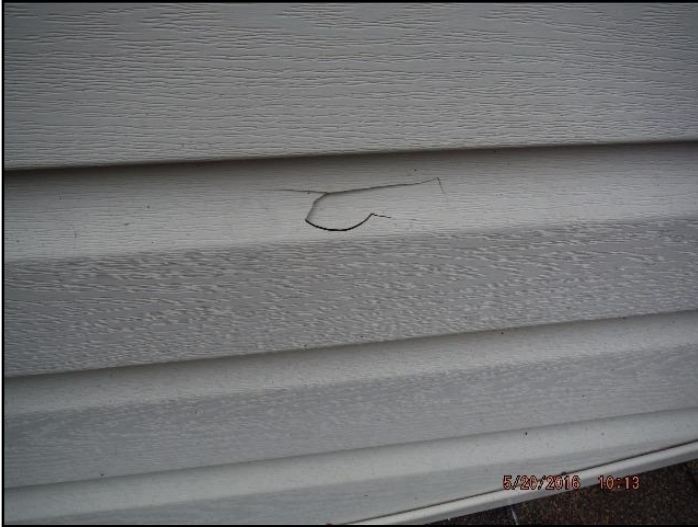
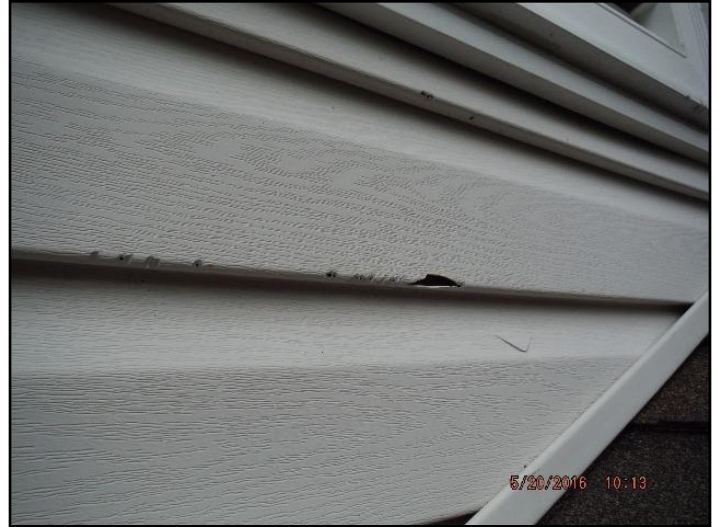
Condition: • Recommend repair or replacement of damaged siding to limit moisture entry and related damages.

4. Recommend repair or replacement of damaged...

5. Recommend repair or replacement of damaged...

Task: Repair or replace Correct

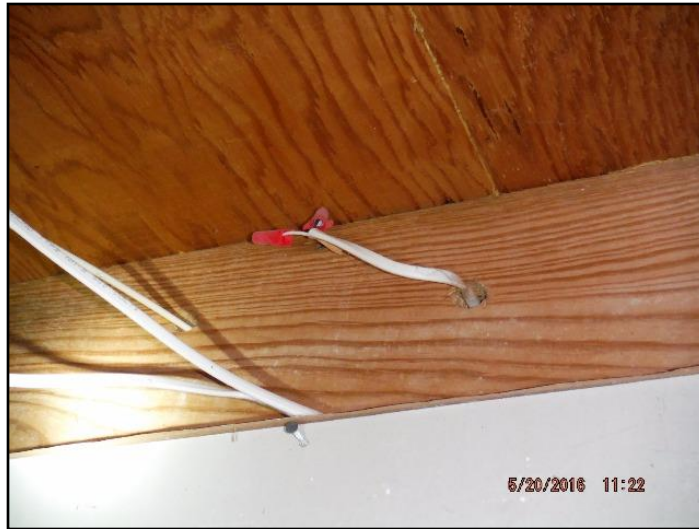
Condition: • [Missing](#)

Noted exposed live wire in basement utility room. Recommend properly terminating live wire in a junction box to limit shock/safety hazards.

Implication(s): Electric shock | Fire hazard

6. Missing

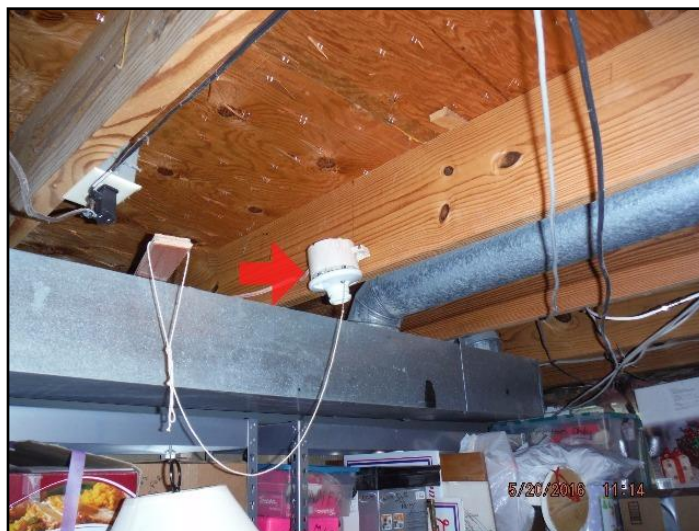
Condition: • [Loose](#)

Noted loose light fixture at basement utility room. Recommend correction to limit safety hazards.

Implication(s): Electric shock | Fire hazard

7. Loose

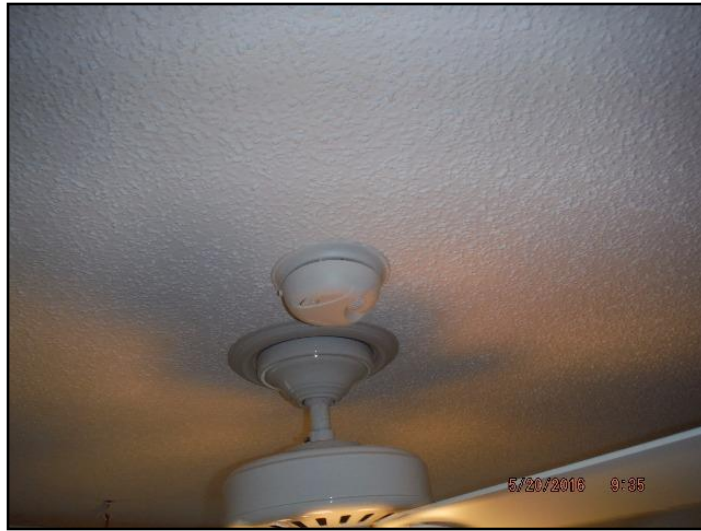
Condition: • Noted improper location of bedroom smoke detectors. Recommend locating 6-12" from bedroom door, high on the wall or ceiling.

9. Noted improper location of bedroom smoke...

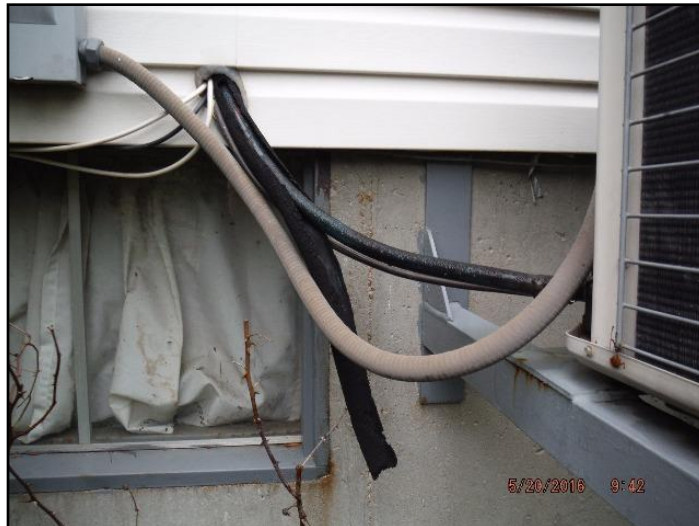
Condition: • Recommend replacement of damaged insulation to ensure proper operation and help improve efficiency of unit.

11. Recommend replacement of damaged insulation...

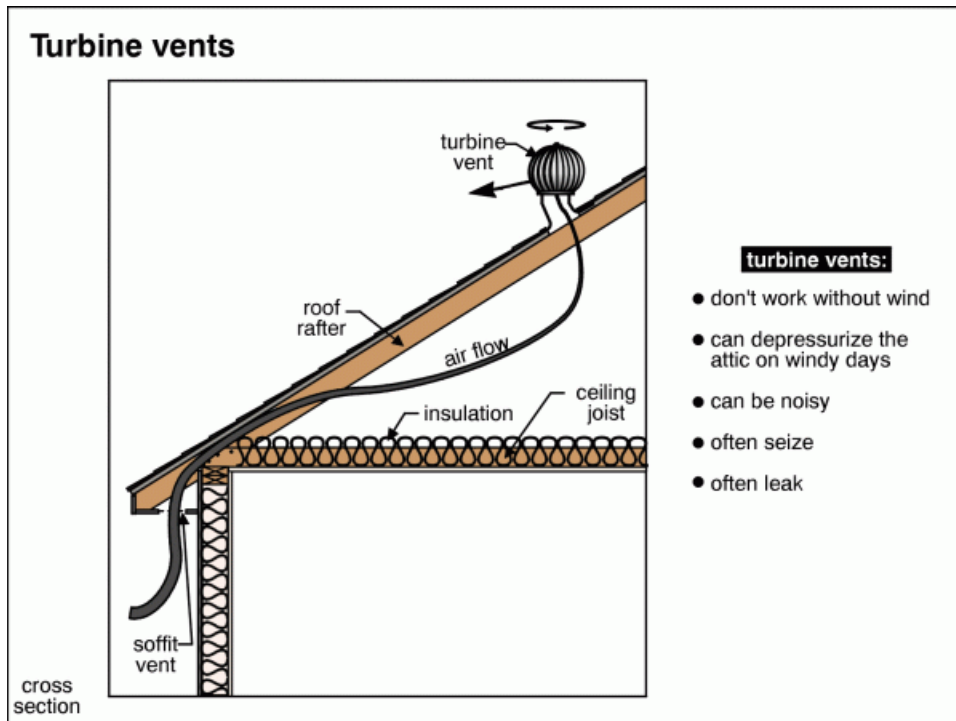
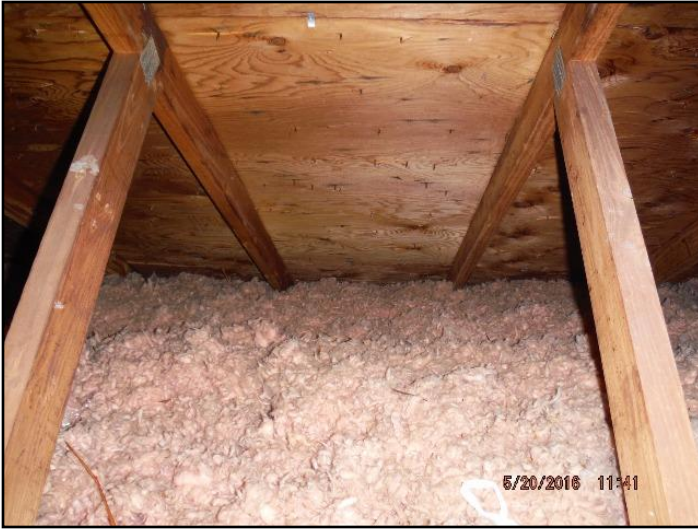
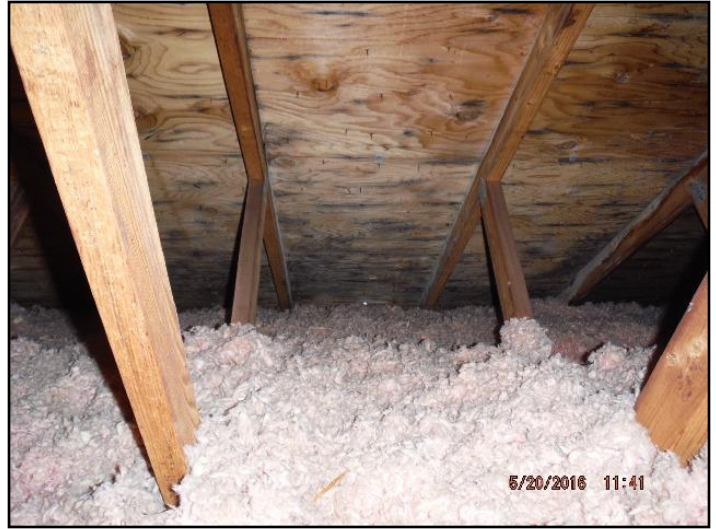
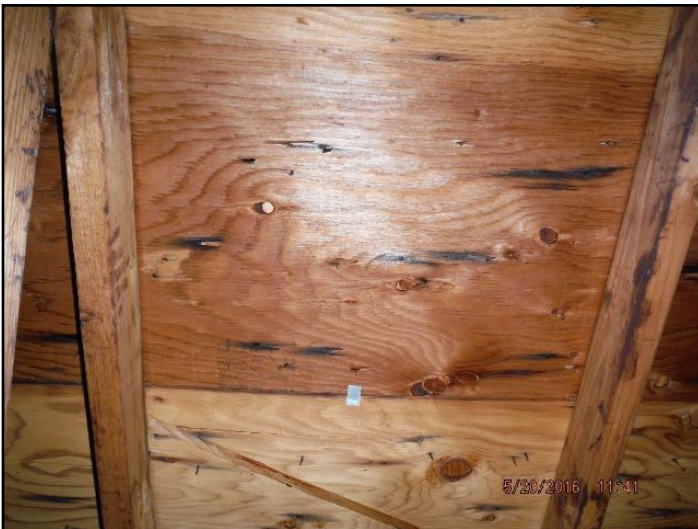
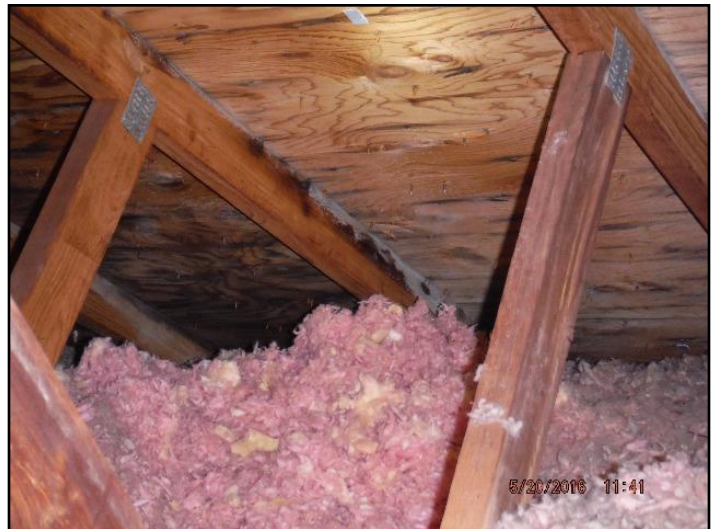
Condition: • Recommend improving attic ventilation

Noted evidence of lack of attic ventilation by rust on roofing nails and what appears to be a minor amount of mold/mildew. It appears the only attic ventilation is from gable end vents. There is vented soffit material but it appears the soffits are not vented, but could not verify as soffit area is covered by insulation. Recommend further evaluation of soffit area to verify weather or not soffits are vented. And if soffits are vented recommend removing insulation from soffit area and installing a ridge vent. If soffits are not vented, recommend installing a power attic fan at gable vents.

12. Recommend improving attic ventilation

13. Recommend improving attic ventilation

14. Recommend improving attic ventilation

15. Recommend improving attic ventilation

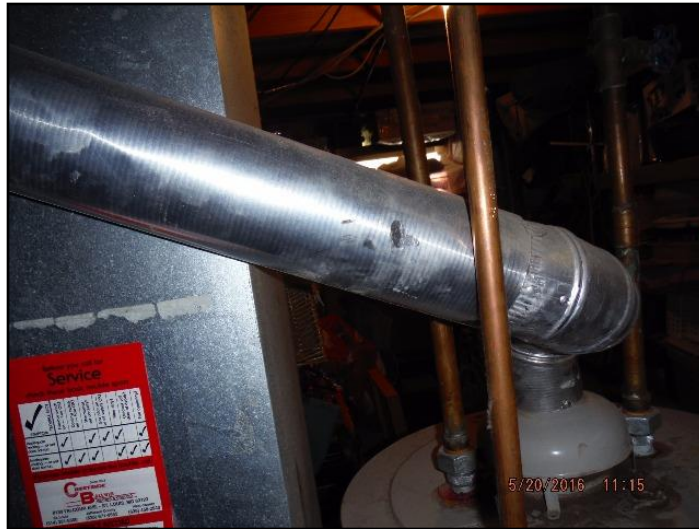
Condition: • [Improper material](#)

Noted aluminum exhaust piping at water heater. Recommend replacement with galvanized steel type piping and install/secure with 3 screws per joint/section of piping.

Implication(s): Equipment not operating properly | Hazardous combustion products entering home

16. Improper material

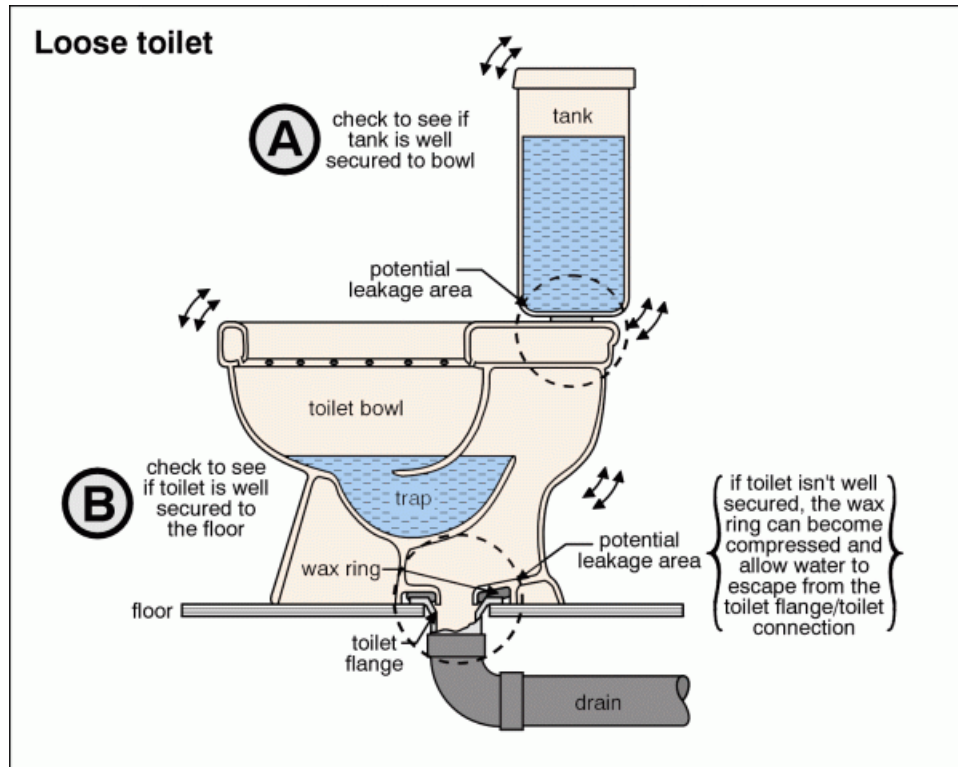
Condition: • [Loose](#)

Noted main level guest bathroom toilet was loose at floor. Recommend correction to limit potential leakage.

Implication(s): Chance of water damage to contents, finishes and/or structure | Sewage entering the building

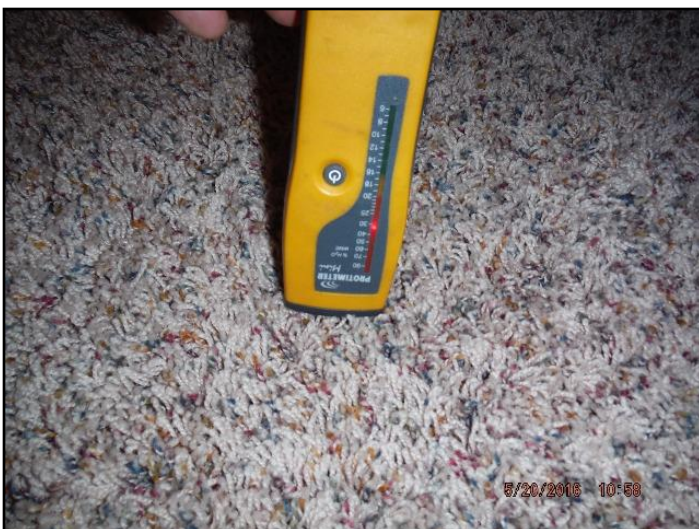
20.

Condition: • Wet. Noted basement carpet was wet/damp at time of inspection at front corner of basement by main water shut off/electrical panel area. Recommend further evaluation by a qualified contractor and correct/repair as needed to limit water/moisture.

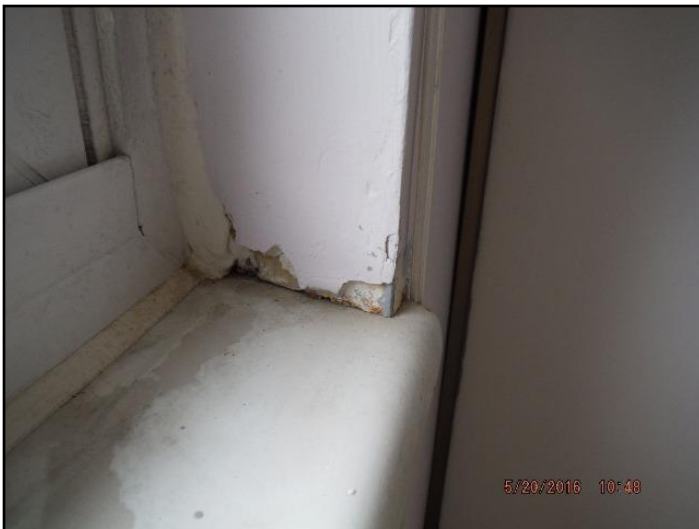
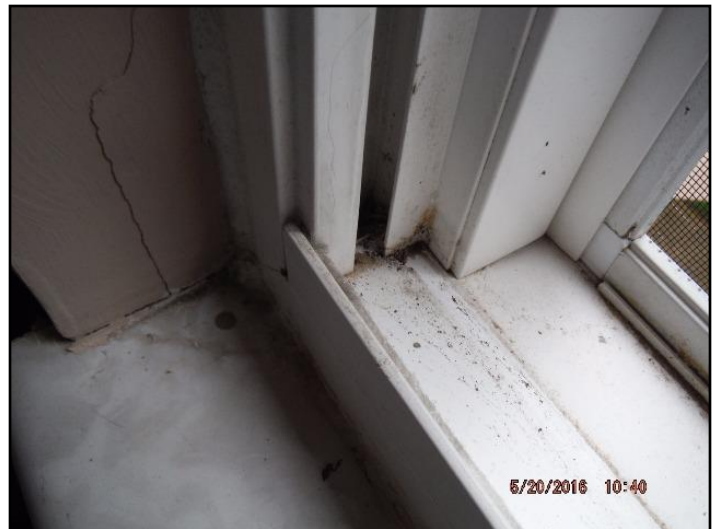
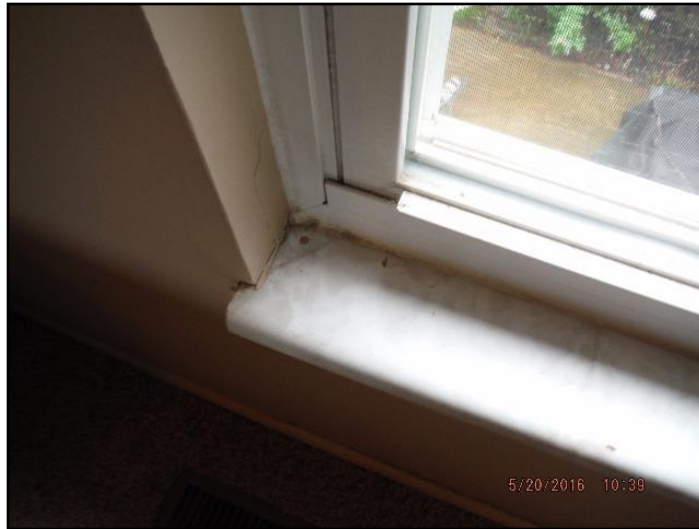
Condition: • Noted what appears to be water staining at window sill.

23. Noted what appears to be water staining at...

24. Noted what appears to be water staining at...

25. Noted what appears to be water staining at...

Recommend keeping window drains clean and free of debris to ensure proper drainage.

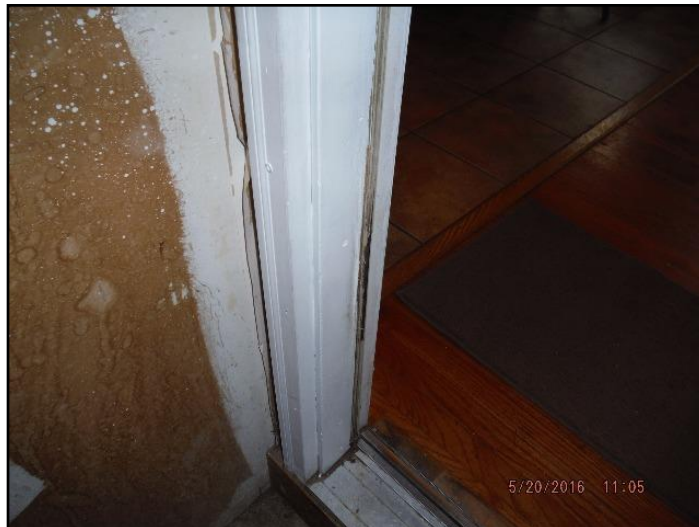
Condition: • [Weatherstripping missing or ineffective](#)

Noted garage man door weather seal is damaged. Recommend replacement to limit safety hazards.

Implication(s): Hazardous combustion products entering home | Increased heating and cooling costs | Reduced comfort

26. Weatherstripping missing or ineffective

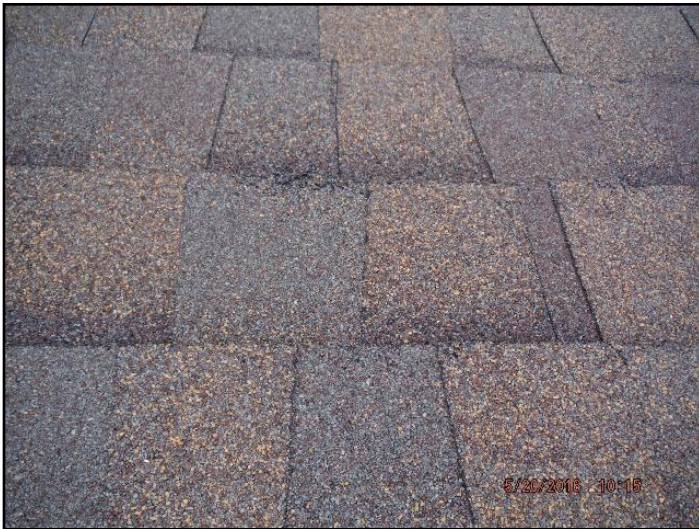
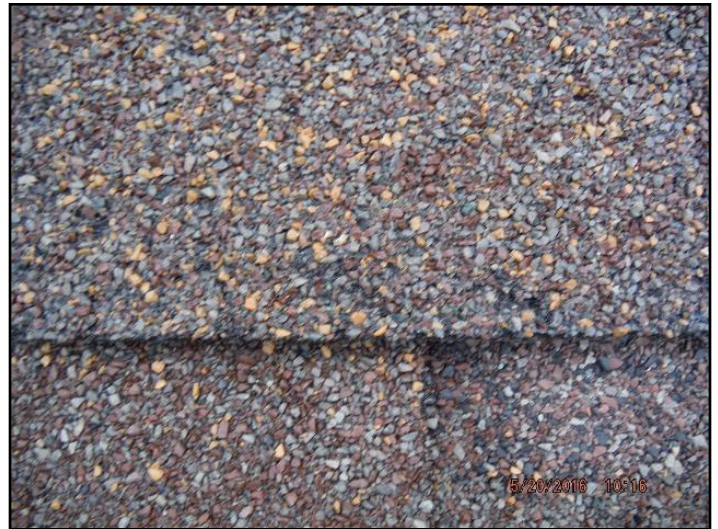
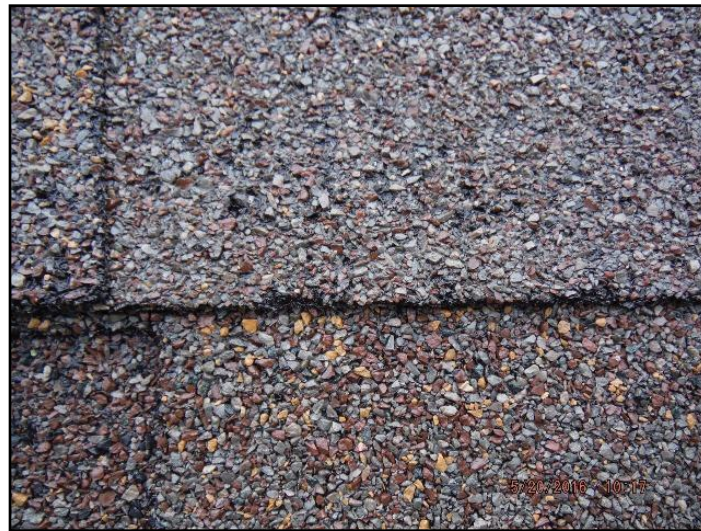
2. **Condition:** • Hail damage

Noted what appears to be minor/moderate amounts of hail damage. Roof covering is hard to view/inspect when wet. Recommend further evaluation by a qualified roofing contractor to determine extent of hail damage and repair if needed.

36. Hail damage

37. Hail damage

38. Hail damage

Task: Further evaluation

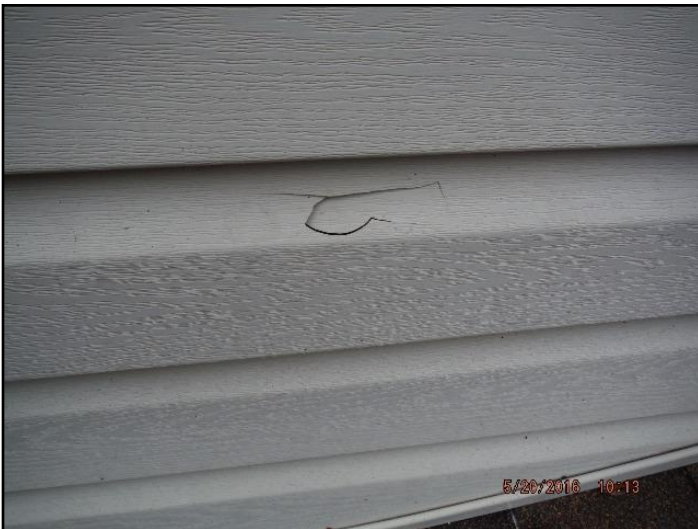
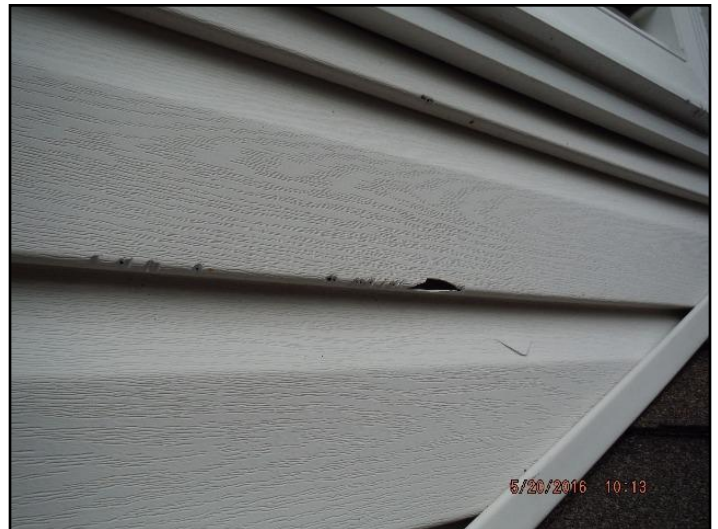
6. Condition: • Recommend repair or replacement of damaged siding to limit moisture entry and related damages.

40. Recommend repair or replacement of damaged...

41. Recommend repair or replacement of damaged...

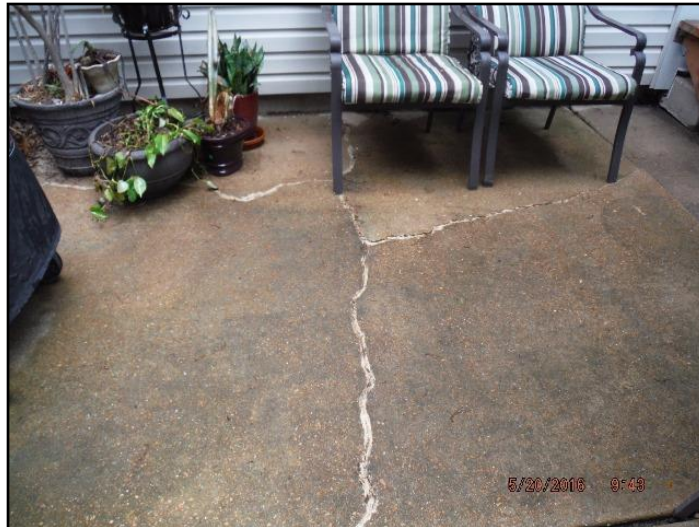
8. **Condition:** • Cracking noted in concrete patio. Suspect this is from minor amounts of settlement. Recommend sealing crack to limit water entry and monitor for future movement and repair/replace as needed.

43. Cracking noted in concrete patio. Suspect...

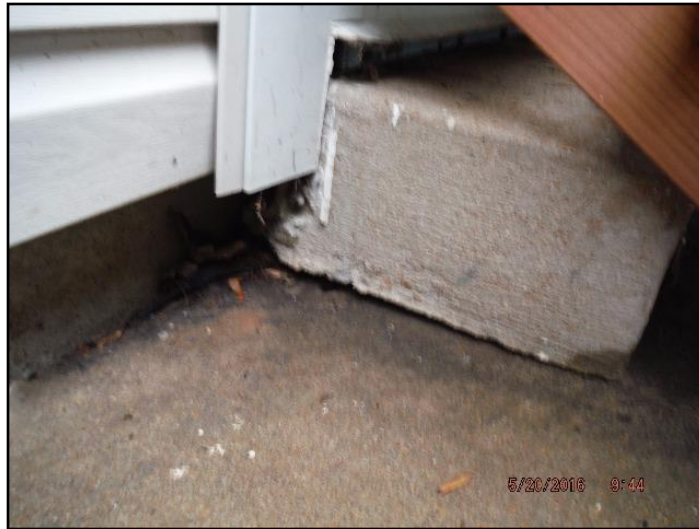
9. **Condition:** • Noted settlement of concrete patio slabs at rear of house. Recommend correction to limit potential trip/safety hazards and further settlement.

44. Noted settlement of concrete patio slabs at...

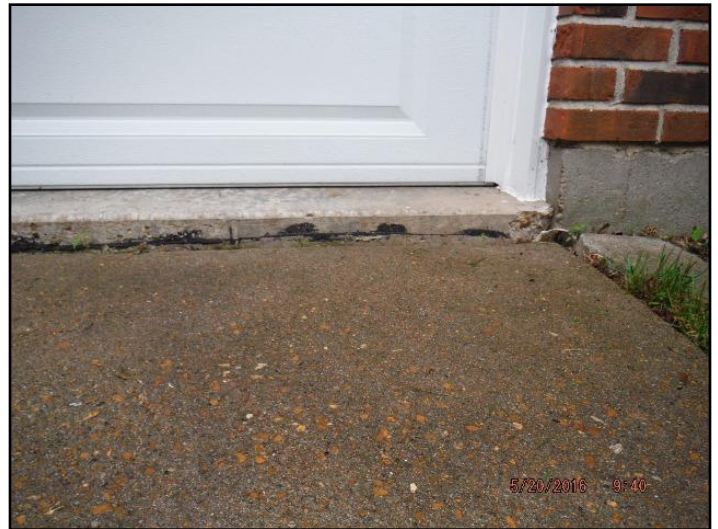
10. Condition: • Settlement/Shifting

Noted settlement in driveway. Recommend correction to limit trip hazard.

46. Settlement/Shifting

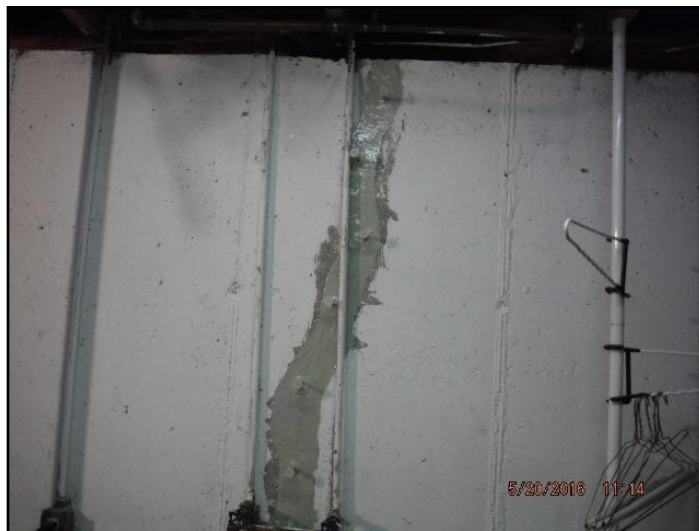
11. Condition: • [Prior repairs](#)

51. *Prior repairs*

Task: Monitor

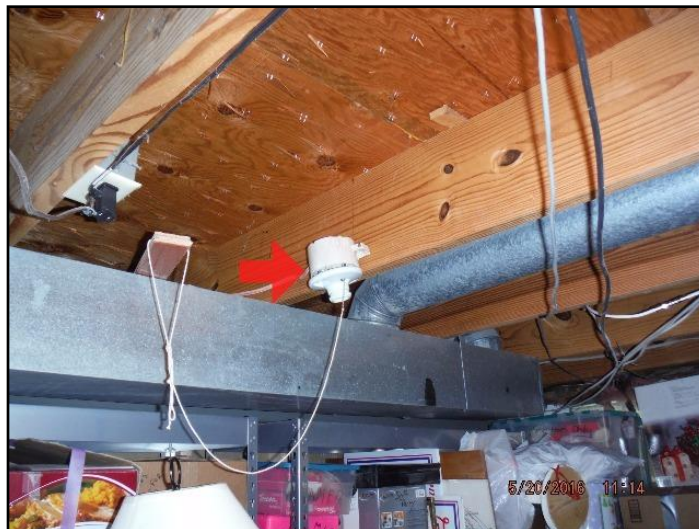
58. Loose

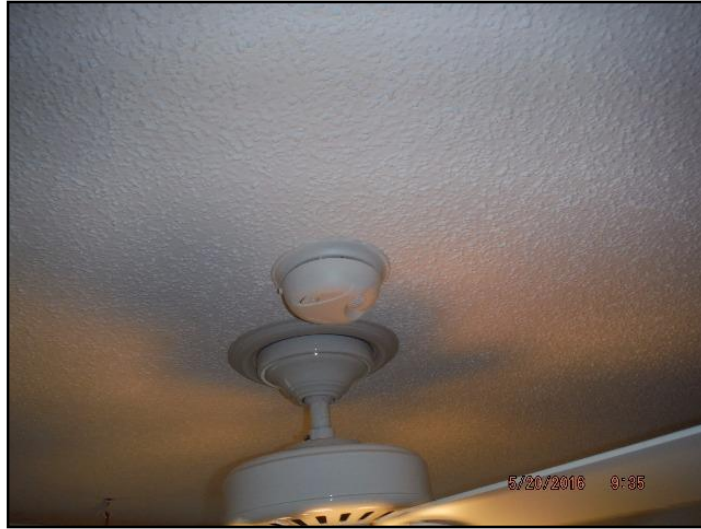
60. *Noted improper location of bedroom smoke...*

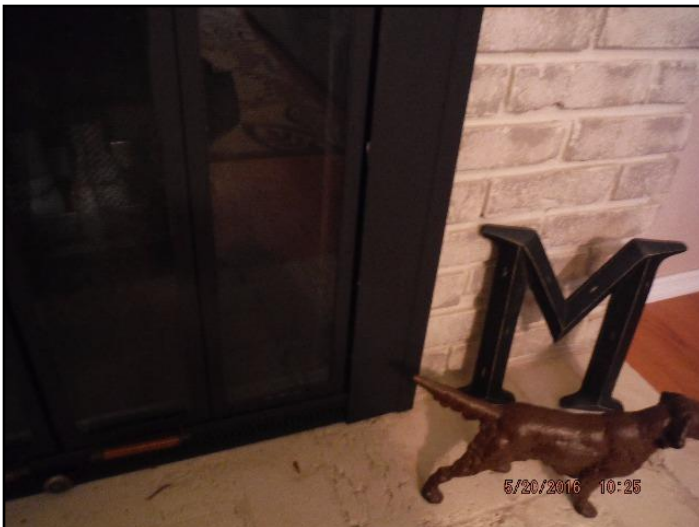
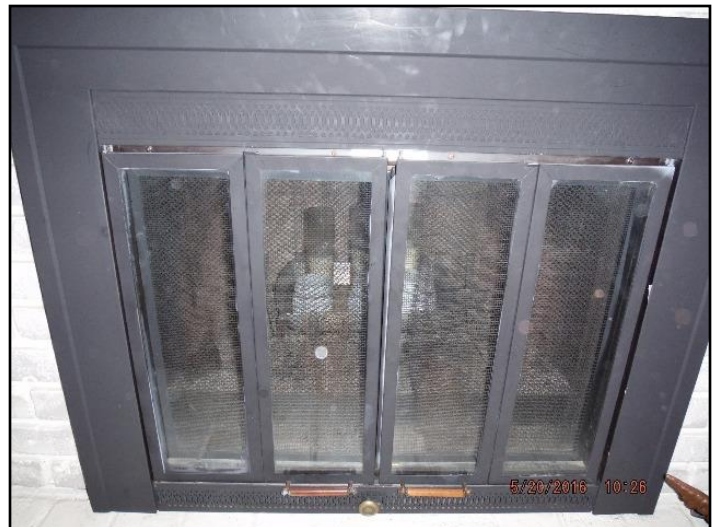
18. Condition: • Noted frame was loose at bottom. Recommend correction to ensure proper function.

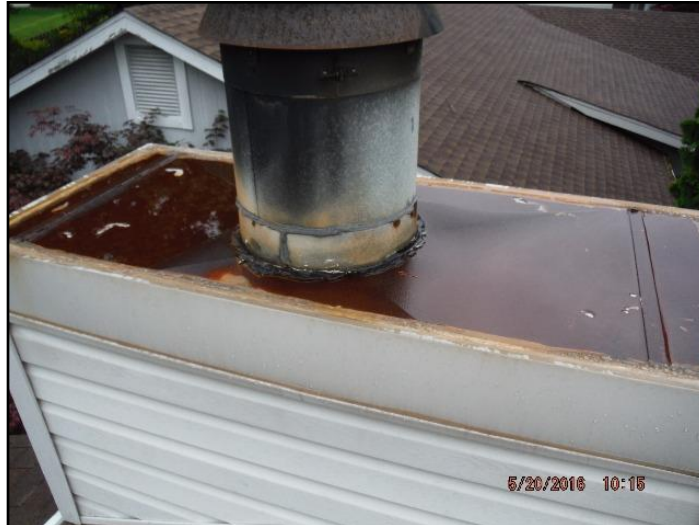
70. *Water ponding*

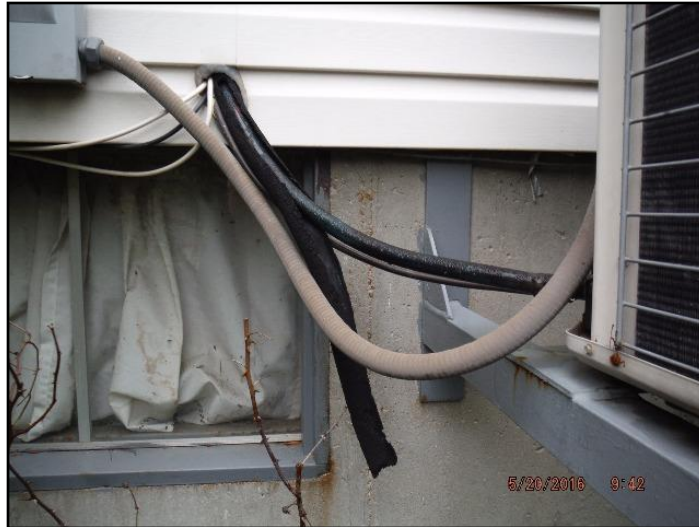
73. *Recommend replacement of damaged insulation...*

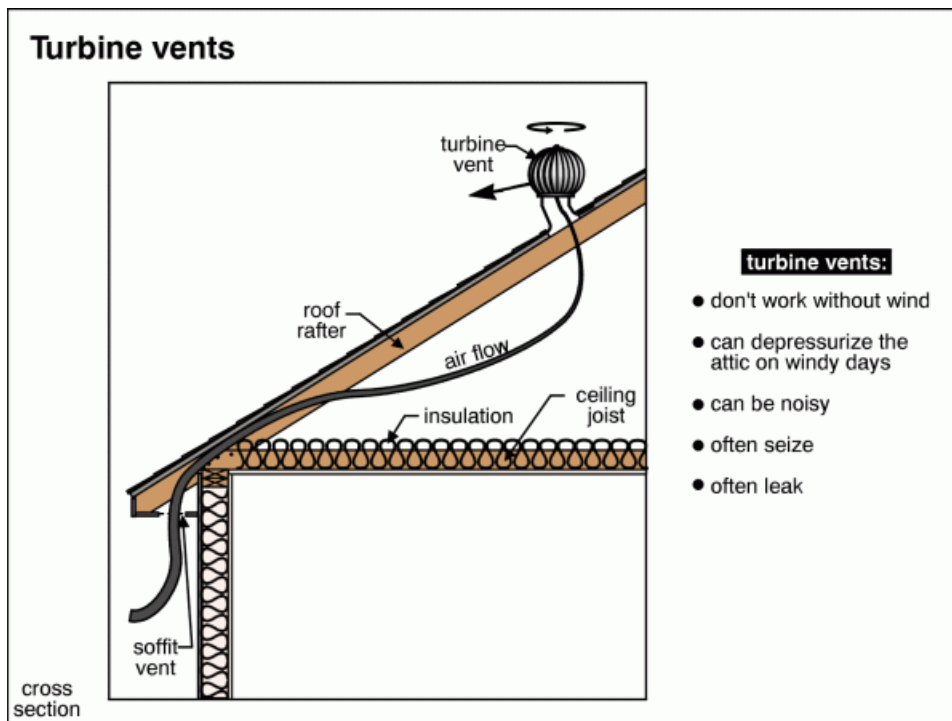
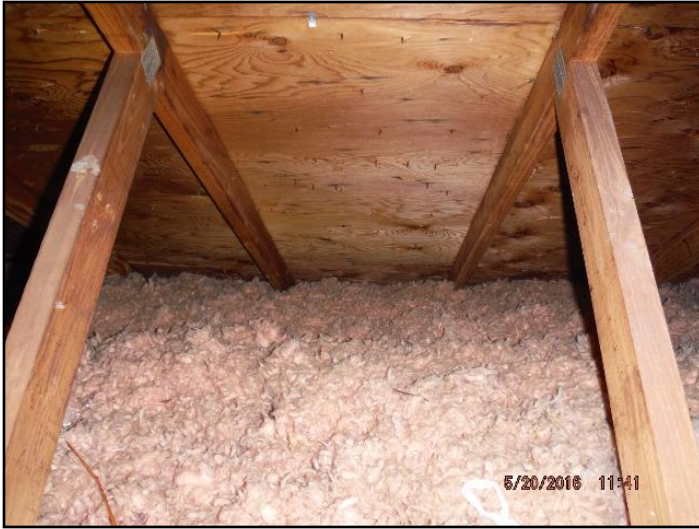
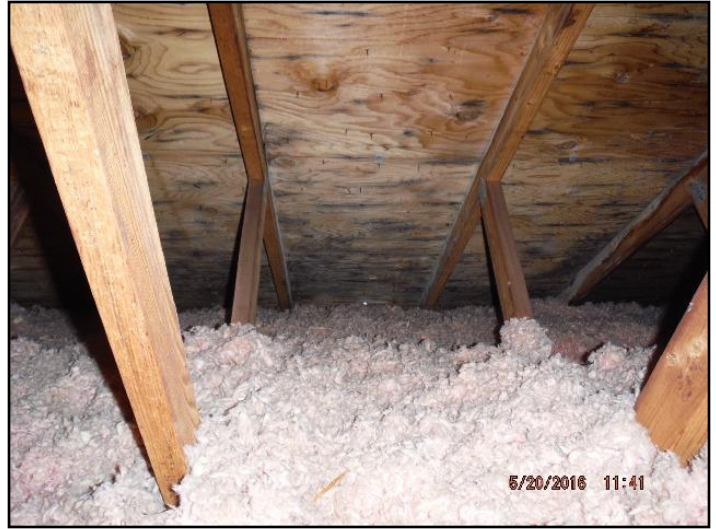
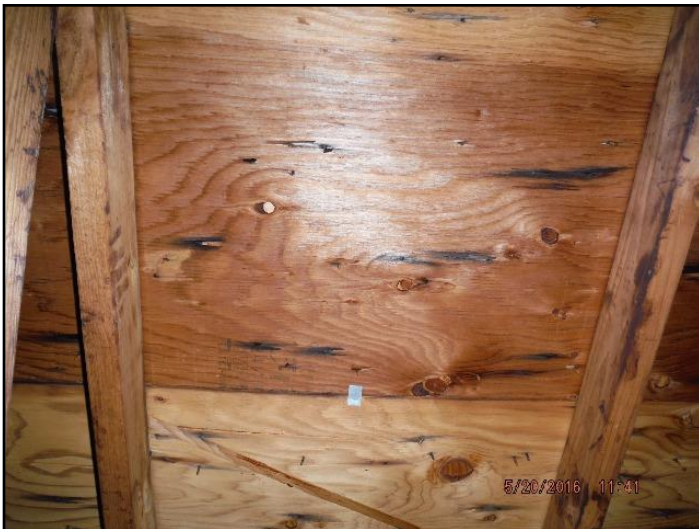
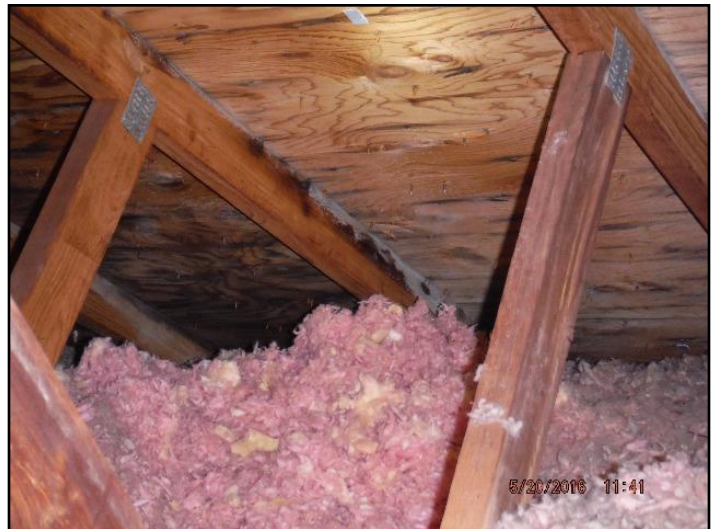
77. Recommend improving attic ventilation

78. Recommend improving attic ventilation

79. Recommend improving attic ventilation

80. Recommend improving attic ventilation

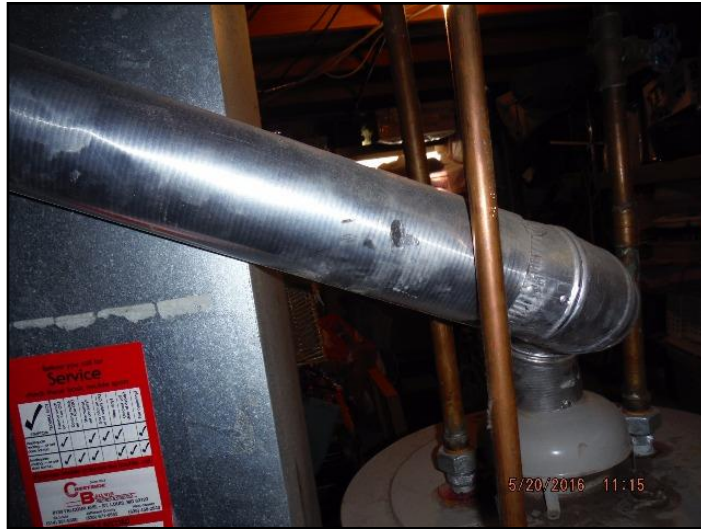
86. Improper material

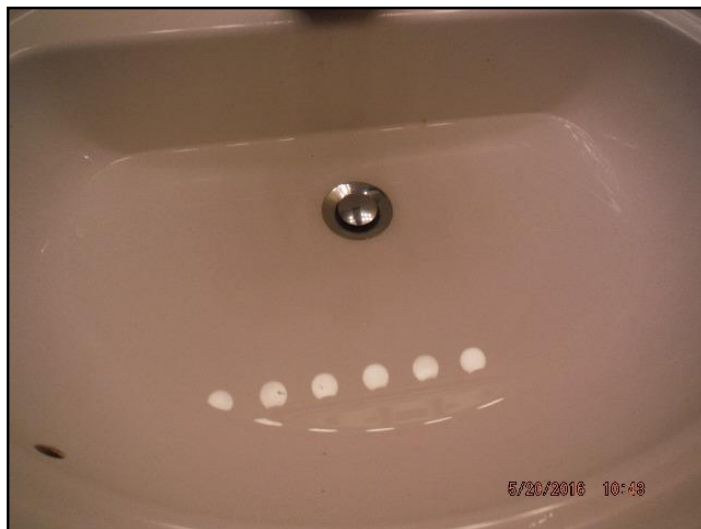
87. Slow drains

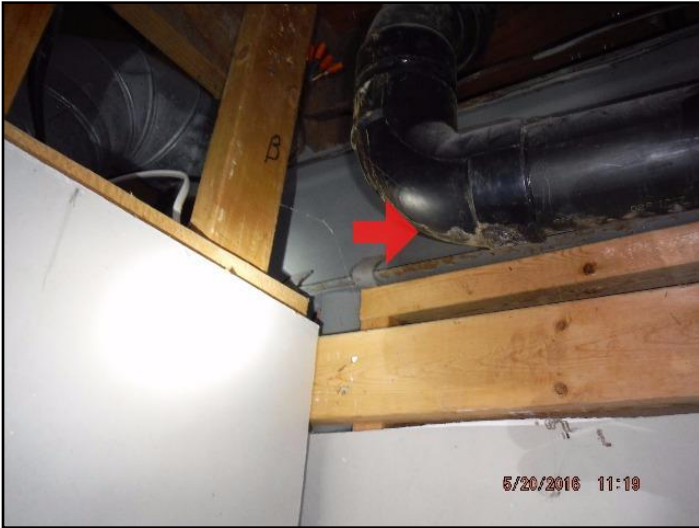
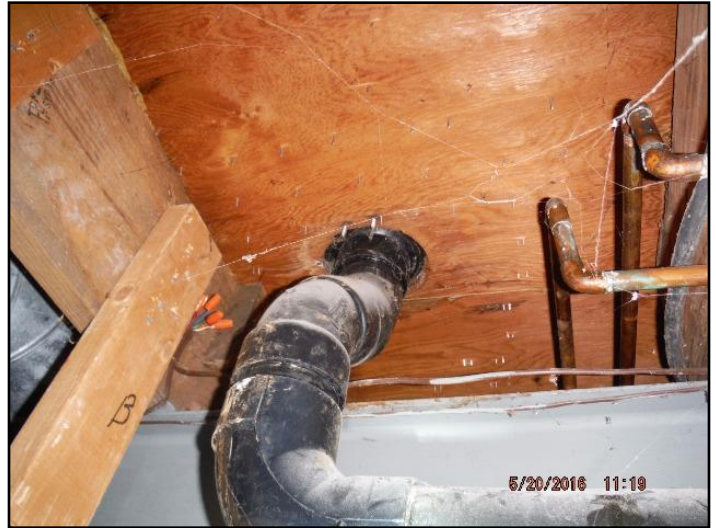
**88.** Evidence of previous leakage at toilet.

**89.** Evidence of previous leakage at toilet.**33. Condition:** • [Loose](#)

Monitor to ensure leak remains inactive

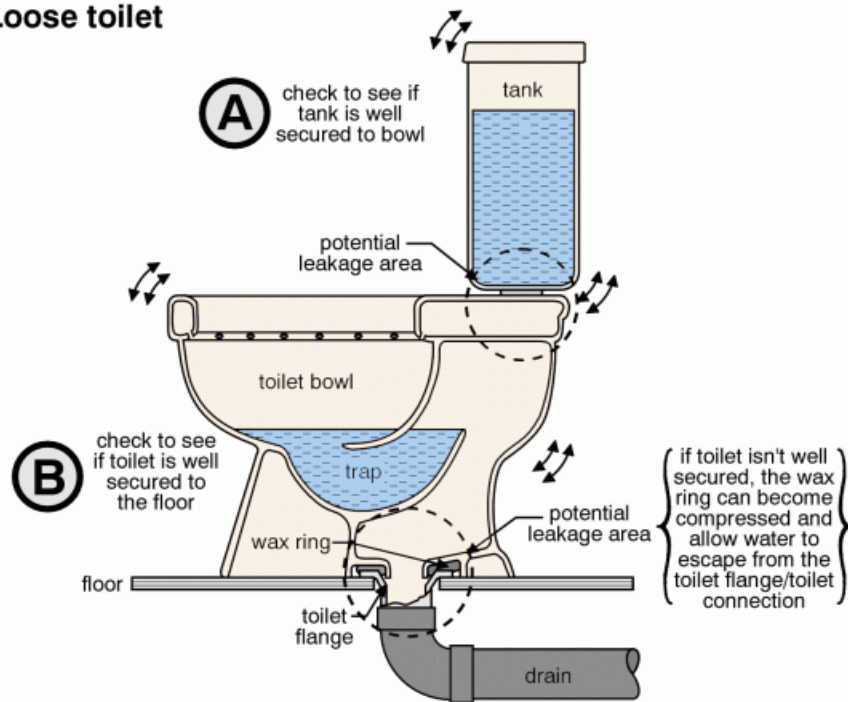
Noted main level guest bathroom toilet was loose at floor. Recommend correction to limit potential leakage.

Loose toilet

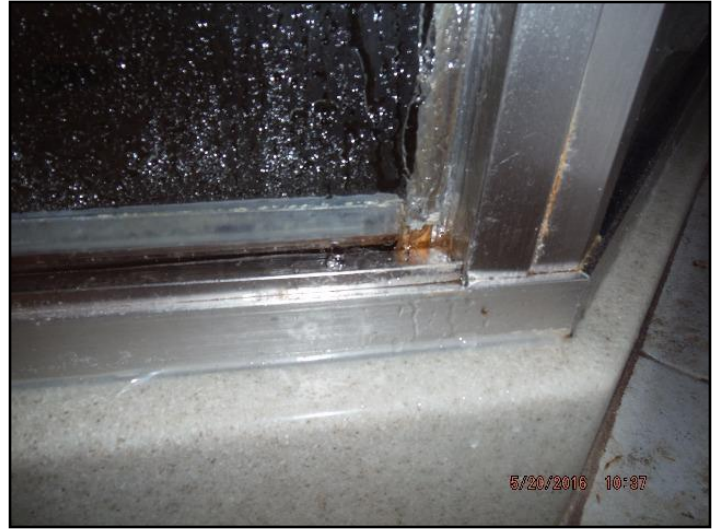
91. Sill and threshold problems

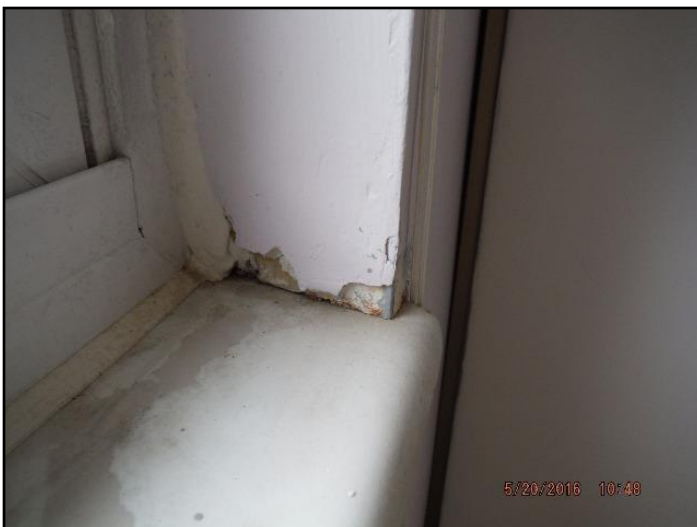
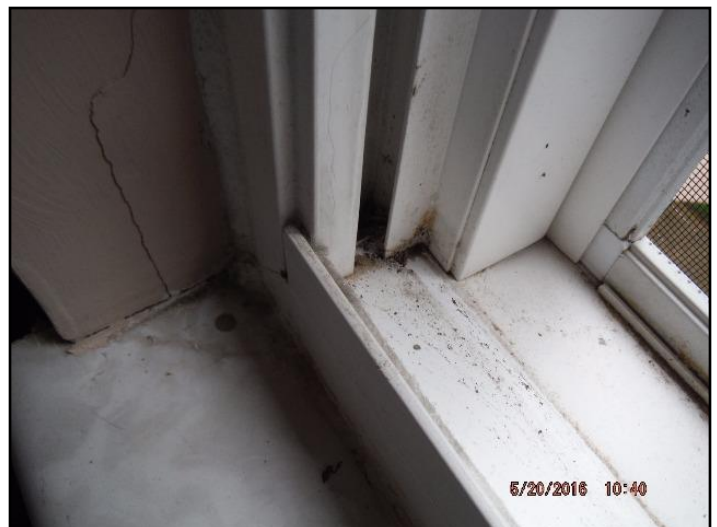
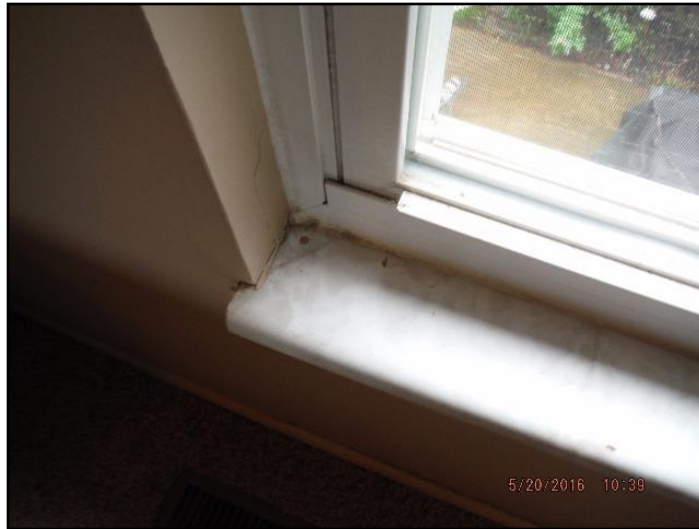
97. Noted what appears to be water staining at...

98. Noted what appears to be water staining at...

99. Noted what appears to be water staining at...

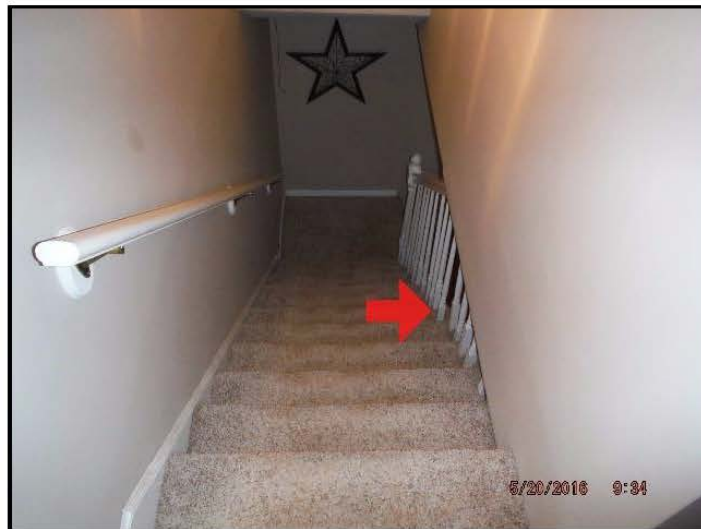
100. Loose

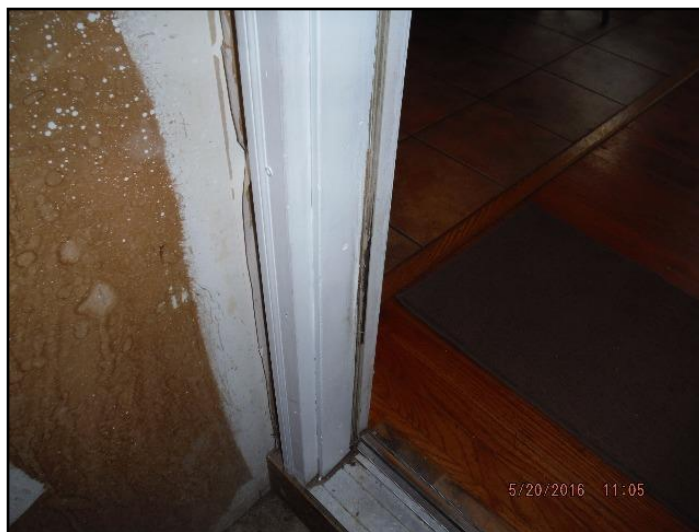
103. Weatherstripping missing or ineffective
