Your Inspection Report

XXX Garden Dr
St Louis, MO 63021

Friday, May 20, 2016

RE: Report No. 1142, v.2
XXX Garden Dr.
St Louis, MO
63021

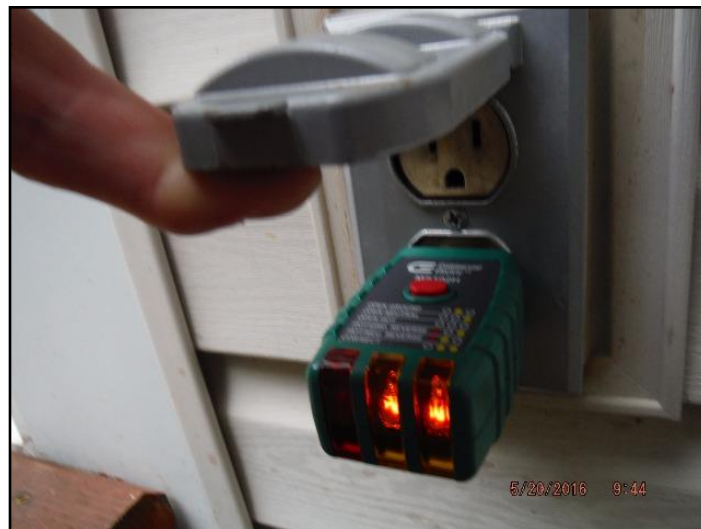
Condition: • [No GFCI \(Ground Fault Circuit Interrupter\)](#)

8. No GFCI (Ground Fault Circuit Interrupter)

Task: Provide Correct Unsafe

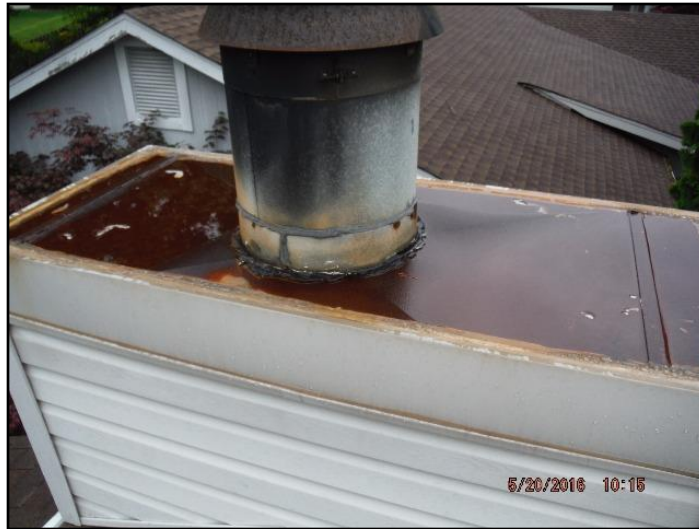
10. Water ponding

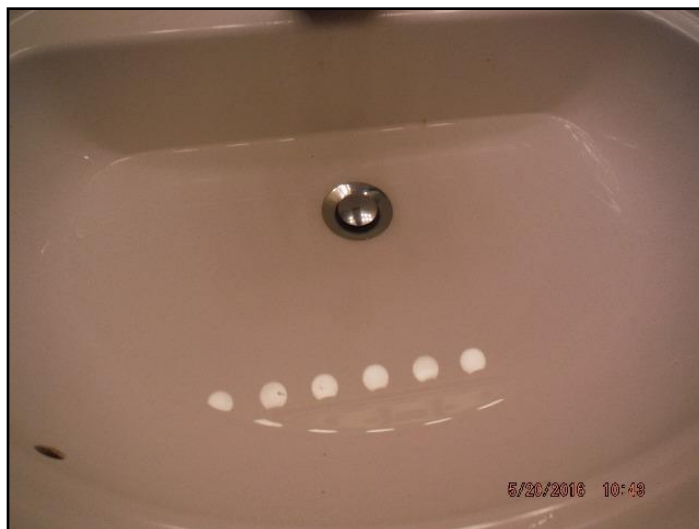
17. Slow drains

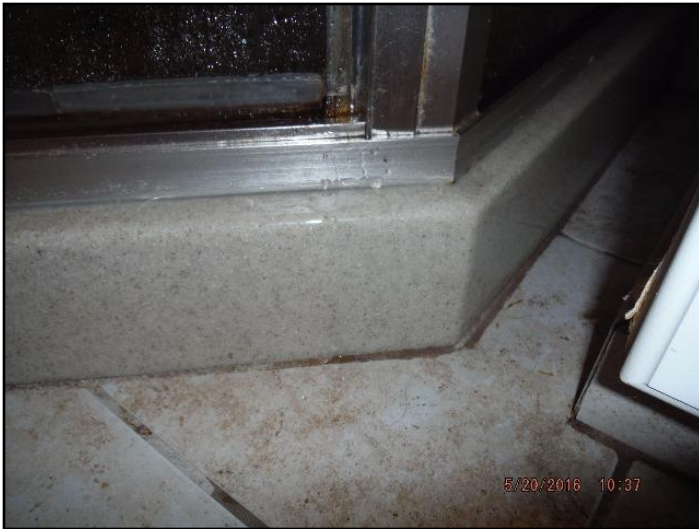
18. Sill and threshold problems

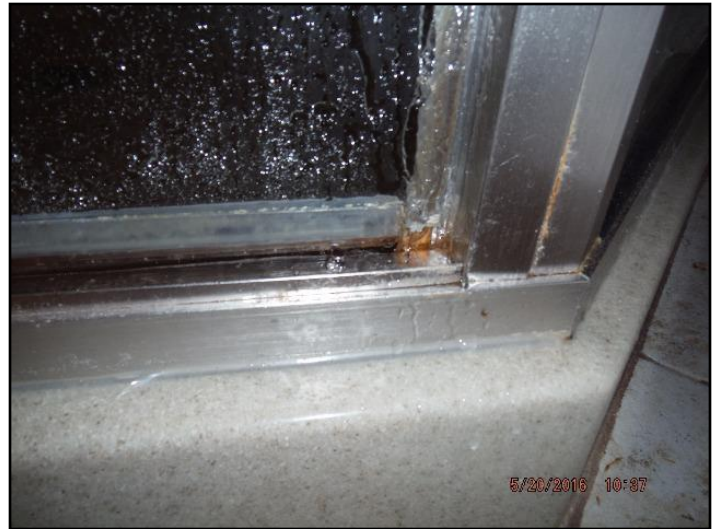
19. Sill and threshold problems

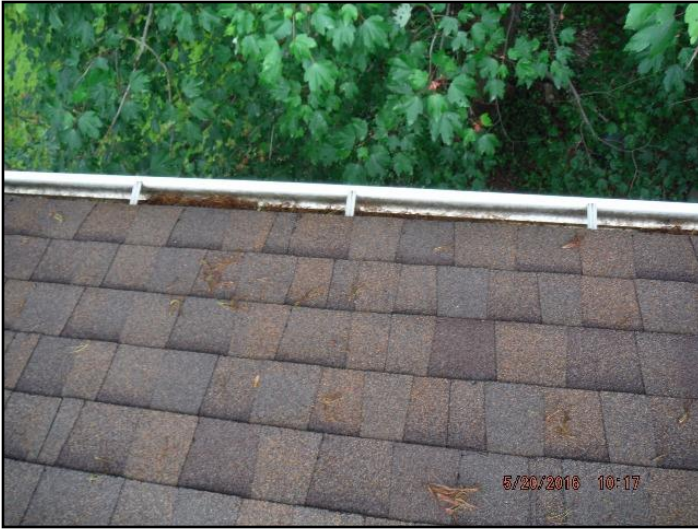
33. Wet roof surface hides flaws

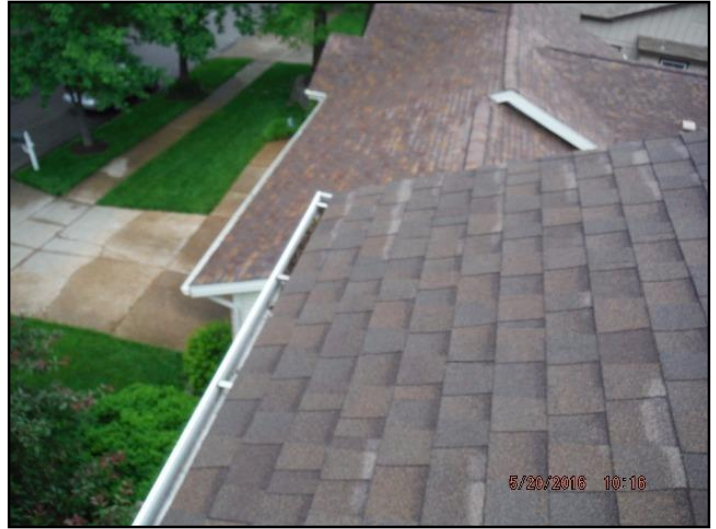
34. Wet roof surface hides flaws

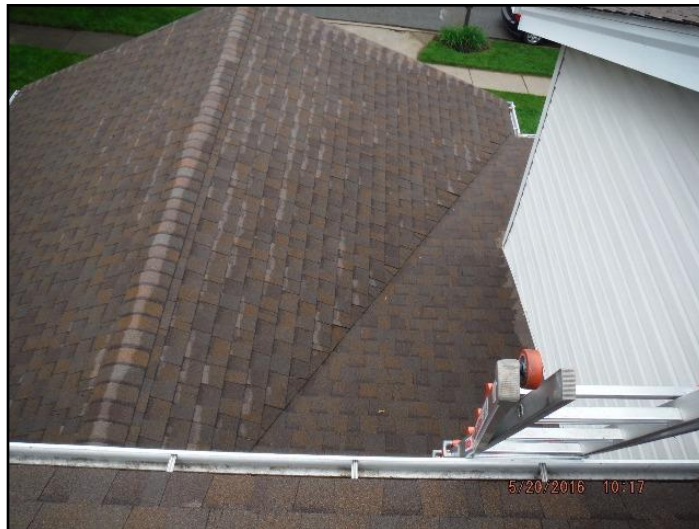
35. Wet roof surface hides flaws

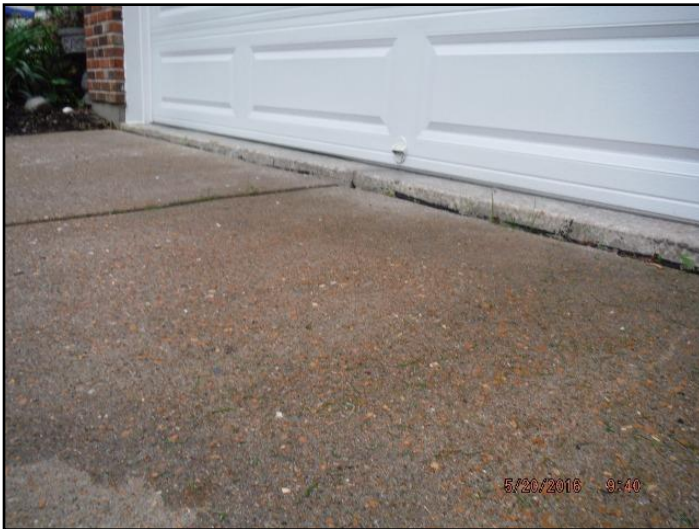
45. Settlement/Shifting

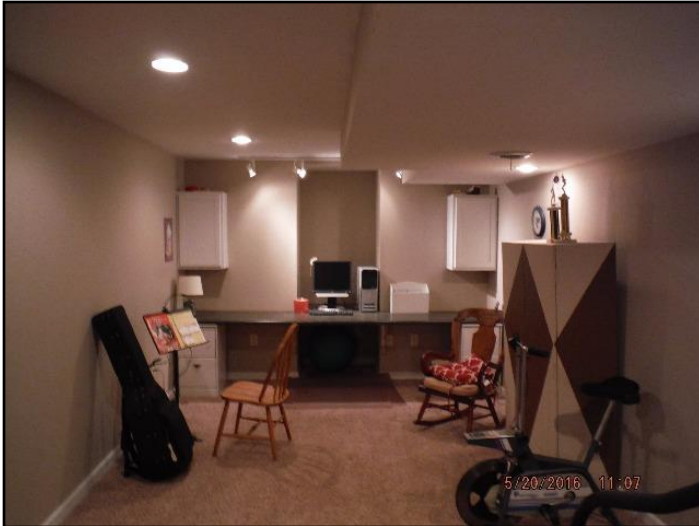
General: • Finished areas of basement and a large amount of storage items limited inspection of most areas of structure and its components.

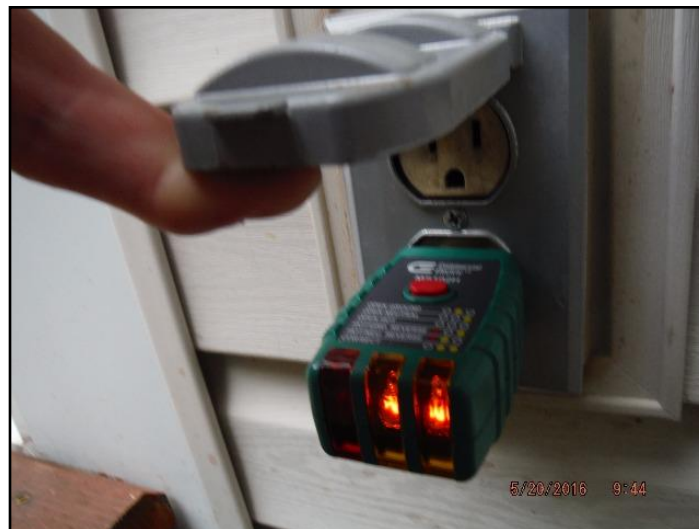
59. No GFCI (Ground Fault Circuit Interrupter)

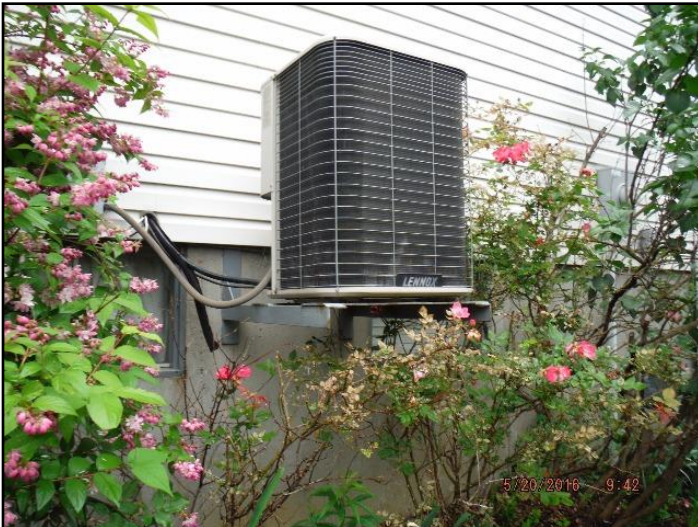
71. Lennox

Manufacturer:

• Lennox

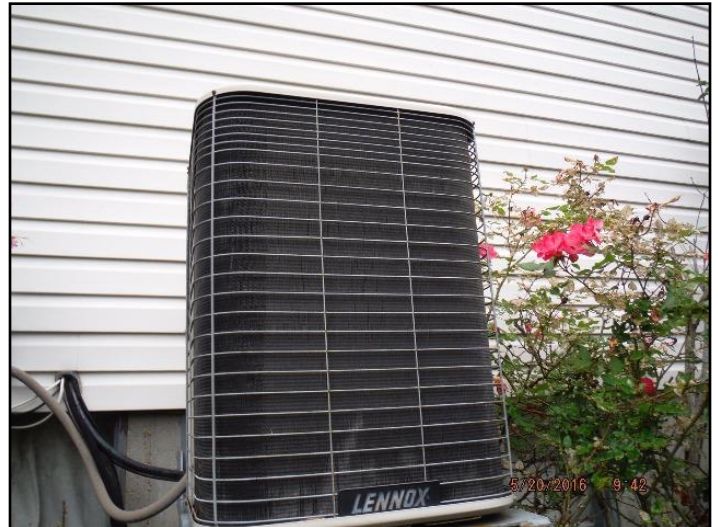
72. Lennox

Compressor approximate age: • Unable to view data plate on unit. Compressor age unknown

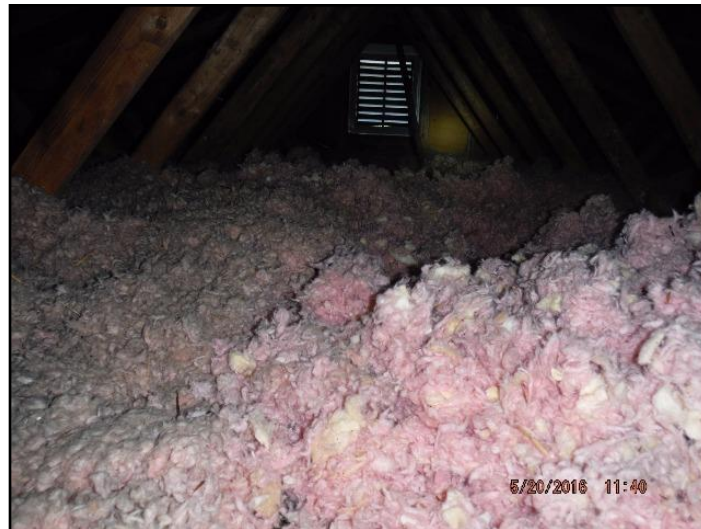
74. Glass fiber

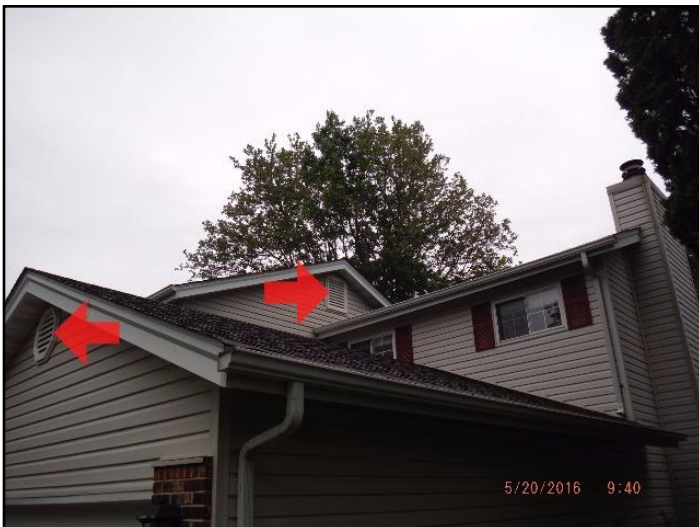
75. Gable vent

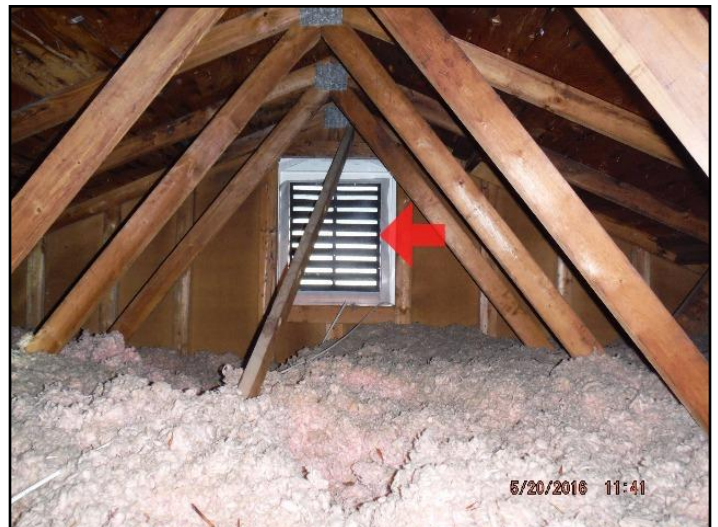
76. Gable vent

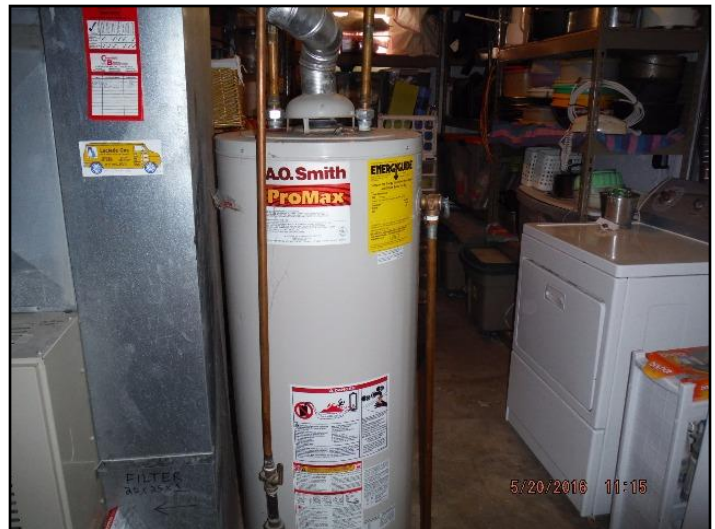
82. A.O. Smith

Water heater is nearing the end of its life expectancy per the manufacturers warranty period of 8-12 years. They typically last longer but cannot predict when unit will fail recommend budgeting for replacement during your ownership.

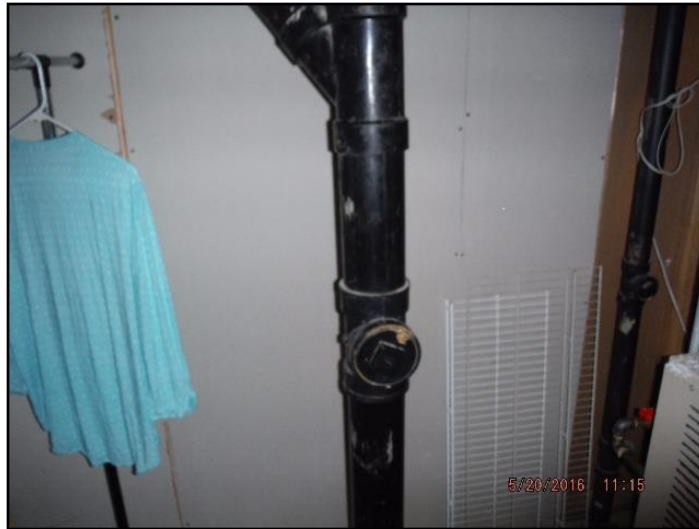
85. ABS plastic

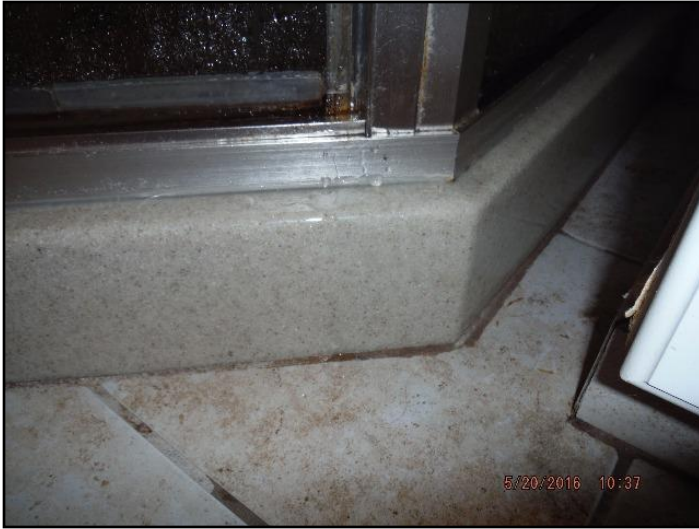
90. Sill and threshold problems

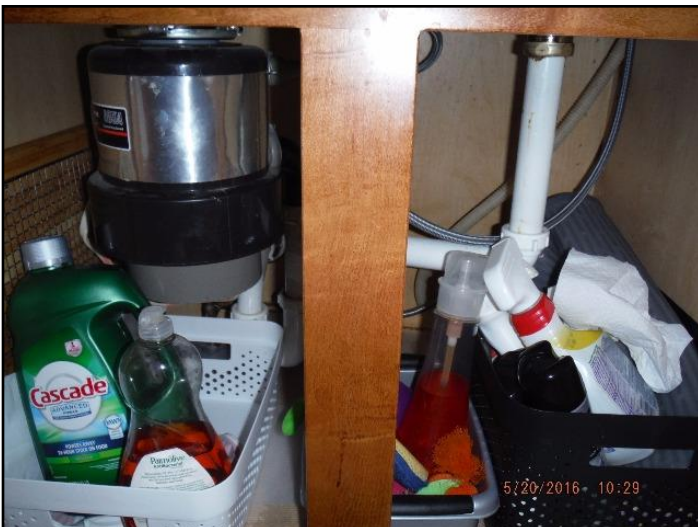
92. Storage in closets/cupboards

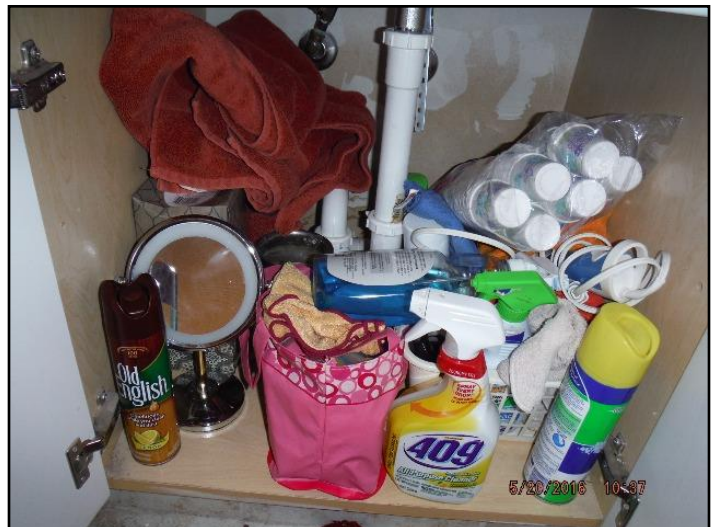
93. Storage in closets/cupboards

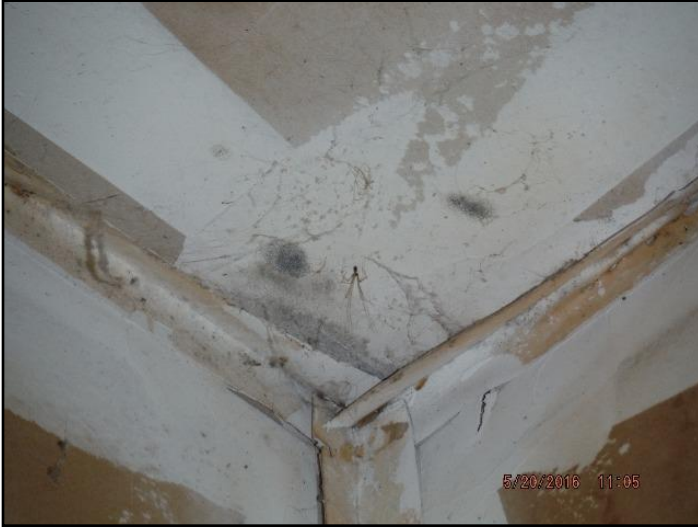
101.

Location: Garage ceiling

Task: Monitor, Repair as needed

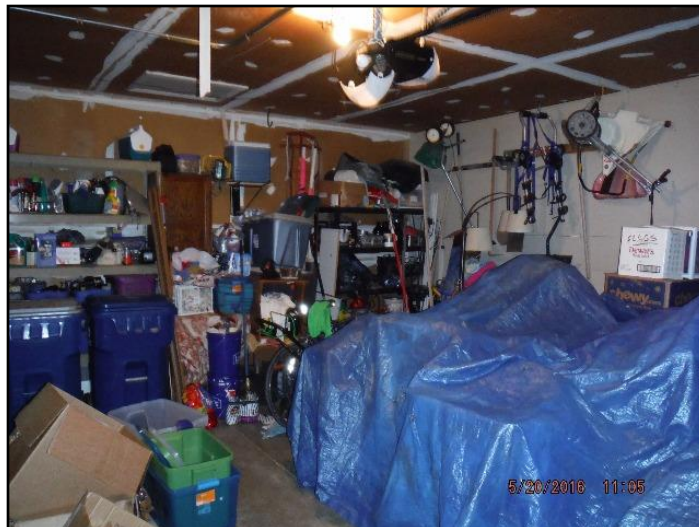
General: • Storage items limit inspection of garage and structure. Pay special attention to this area during your final walk through.

104. Storage items limit inspection of garage an...
